EO STERILIZATION
Quality Control Report

LOT : 01006	**STERILIZATION DATE : 23-Oct-2024**	**EXPIRE DATE : 23-Oct-2029**

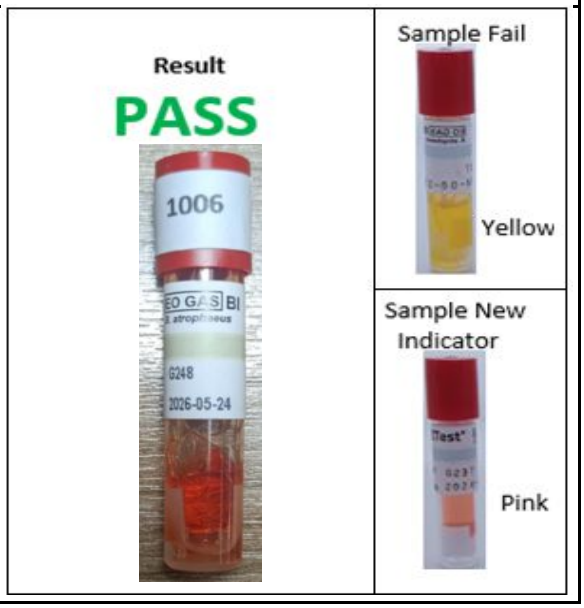
PASS as the test result has been shown as pictures below.

After sterilization the chemical indicator ring on the label changes from blue to brownish when exposed to Ethylene Oxide (EO gas). This distinguishes exposed from unexposed units (it does not indicate acceptable sterilization).

After the incubation period of 48 hours, the appearance of a yellow color indicates bacterial growth. No color change indicates adequate sterilization.
