EO STERILIZATION
Quality Control Report

Date : 27-OCT-2023

LOT : 902	**STERILIZATION DATE : 20-OCT-2023**	**EXPIRE DATE : 20-OCT-2028**

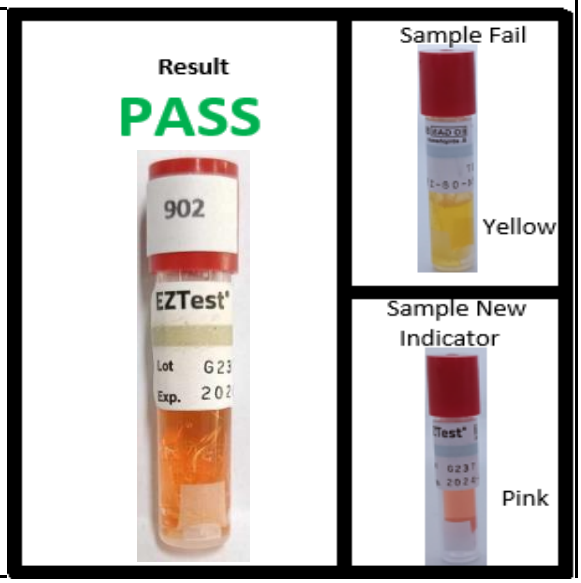
PASS as the test result has been shown as pictures below.

After sterilization the chemical indicator ring on the label changes from blue to brownish when exposed to Ethylene Oxide (EO gas). This distinguishes exposed from unexposed units (it does not indicate acceptable sterilization).

After the incubation period of 48 hours, the appearance of a yellow color indicates bacterial growth. No color change indicates adequate sterilization.
