EO STERILIZATION
Quality Control Report

Date : 31-OCT-2023

LOT : 903	**STERILIZATION DATE : 24-OCT-2023**	**EXPIRE DATE : 24-OCT-2028**

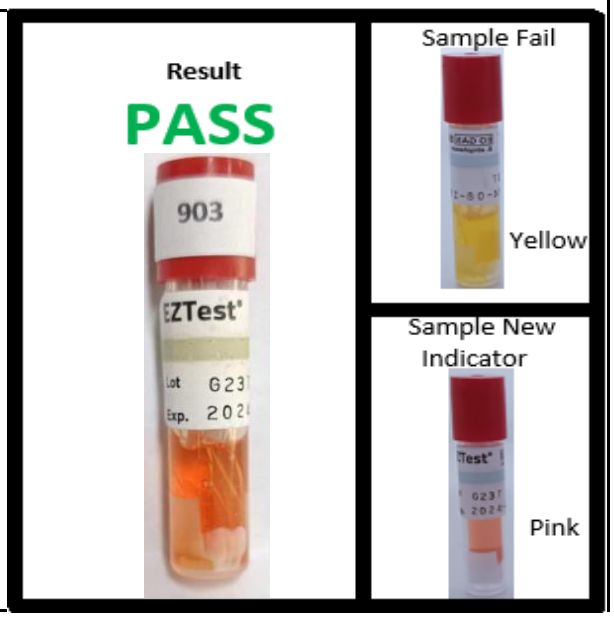
PASS as the test result has been shown as pictures below.

After the incubation period of 48 hours, the appearance of a yellow color indicates bacterial growth. No color change indicates adequate sterilization.
