EO STERILIZATION
Quality Control Report

LOT : 0949	**STERILIZATION DATE : 11-May-2024**	**EXPIRE DATE : 11-May-2029**

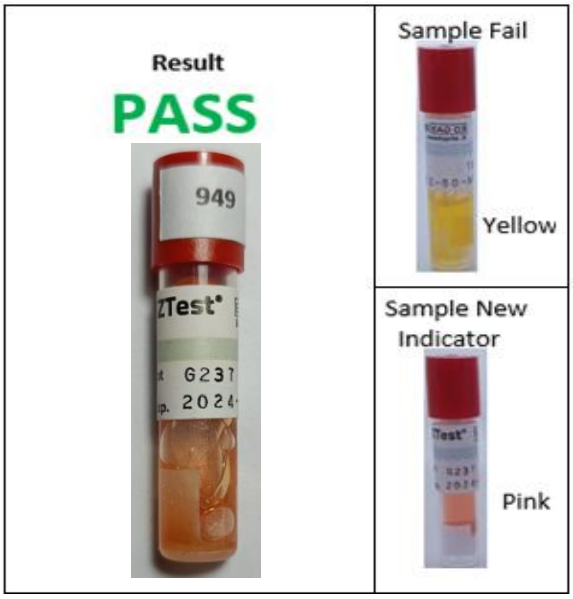
PASS as the test result has been shown as pictures below.

After sterilization the chemical indicator ring on the label changes from blue to brownish when exposed to Ethylene Oxide (EO gas). This distinguishes exposed from unexposed units (it does not indicate acceptable sterilization).

After the incubation period of 48 hours, the appearance of a yellow color indicates bacterial growth. No color change indicates adequate sterilization.
