EO STERILIZATION
Quality Control Report

Date : 29-Nov-2024

LOT : 1023	**STERILIZATION DATE : 27-Nov-2024**	**EXPIRE DATE : 27-Nov-2029**

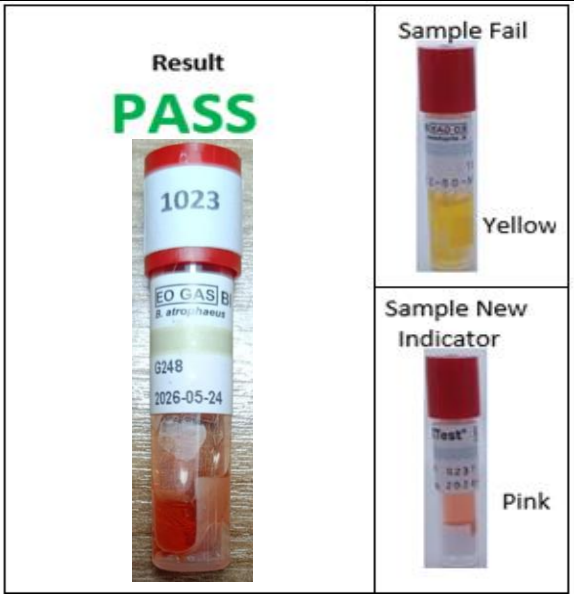
PASS as the test result has been shown as pictures below.

After sterilization the chemical indicator ring on the label changes from blue to brownish when exposed to Ethylene Oxide (EO gas). This distinguishes exposed from unexposed units (it does not indicate acceptable sterilization).

After the incubation period of 48 hours, the appearance of a yellow color indicates bacterial growth. No color change indicates adequate sterilization.
