EO STERILIZATION
Quality Control Report

Date : 31-Mar-2025

LOT : 1062	**STERILIZATION DATE : 22-Mar-2025**	**EXPIRE DATE : 22-Mar-2029**

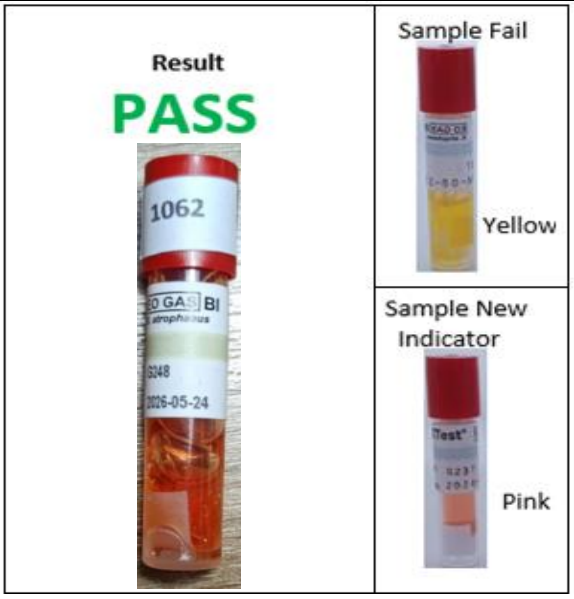
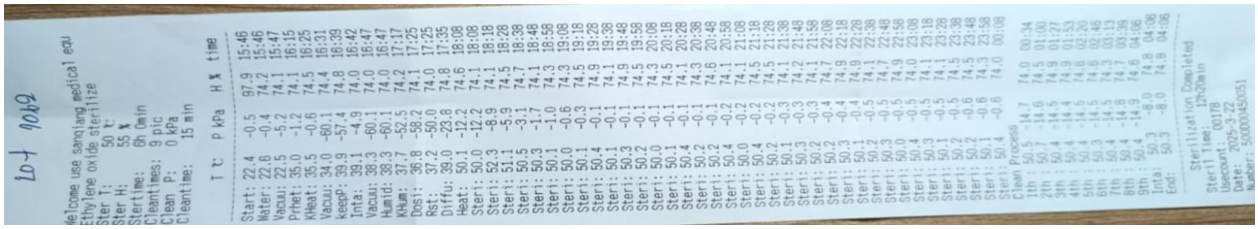
PASS as the test result has been shown as pictures below.

After sterilization the chemical indicator ring on the label changes from blue to brownish when exposed to Ethylene Oxide (EO gas). This distinguishes exposed from unexposed units (it does not indicate acceptable sterilization).

After the incubation period of 48 hours, the appearance of a yellow color indicates bacterial growth. No color change indicates adequate sterilization.
