EO STERILIZATION
Quality Control Report

LOT : 1275	**STERILIZATION DATE : 6-Aug-2026**	**EXPIRE DATE : 6-Aug-2031**

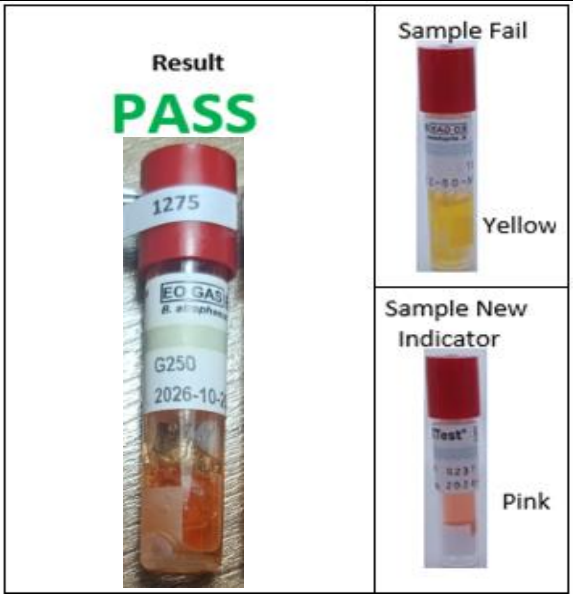
PASS as the test result has been shown as pictures below.

After the incubation period of 48 hours, the appearance of a yellow color indicates bacterial growth. No color change indicates adequate sterilization.
