EO STERILIZATION
Quality Control Report

LOT : 1282	**STERILIZATION DATE : 18-Aug-2026**	**EXPIRE DATE : 18-Aug-2031**

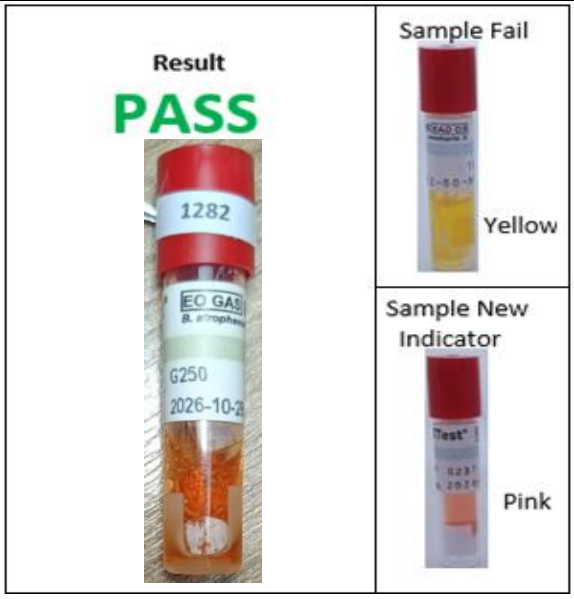
PASS as the test result has been shown as pictures below.

After sterilization the chemical indicator ring on the label changes from blue to brownish when exposed to Ethylene Oxide (EO gas). This distinguishes exposed from unexposed units (it does not indicate acceptable sterilization).

After the incubation period of 48 hours, the appearance of a yellow color indicates bacterial growth. No color change indicates adequate sterilization.
