EO STERILIZATION
Quality Control Report

LOT : 01011	**STERILIZATION DATE : 26-Oct-2024**	**EXPIRE DATE : 26-Oct-2029**

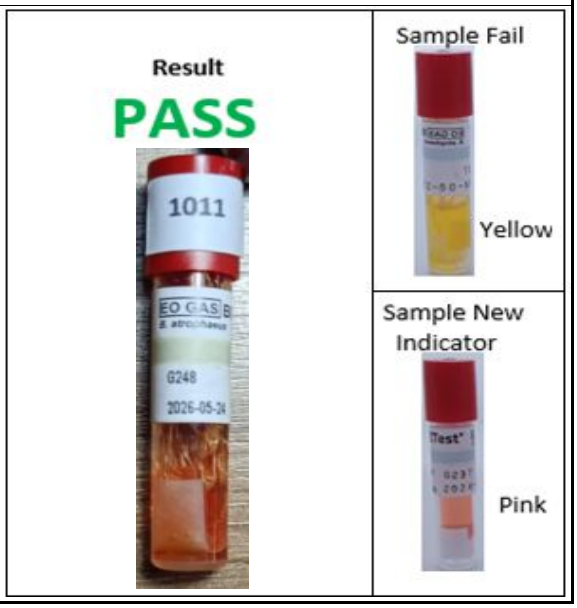
PASS as the test result has been shown as pictures below.

After sterilization the chemical indicator ring on the label changes from blue to brownish when exposed to Ethylene Oxide (EO gas). This distinguishes exposed from unexposed units (it does not indicate acceptable sterilization).

After the incubation period of 48 hours, the appearance of a yellow color indicates bacterial growth. No color change indicates adequate sterilization.
