EO STERILIZATION
Quality Control Report

Date : 06-MAR-2024

LOT : 0931	**STERILIZATION DATE : 01-MAR-2024**	**EXPIRE DATE : 01-MAR-2029**

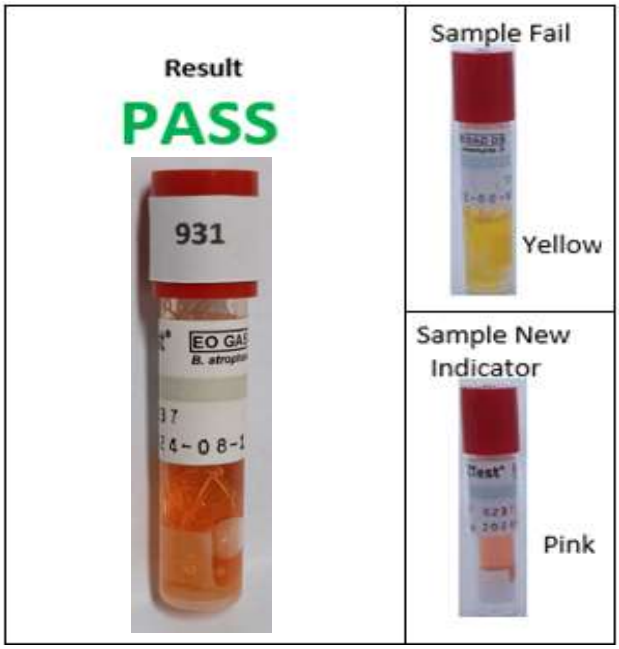
PASS as the test result has been shown as pictures below.

After the incubation period of 48 hours, the appearance of a yellow color indicates bacterial growth. No color change indicates adequate sterilization.
