EO STERILIZATION
Quality Control Report

Date : 06-MAR-2024

LOT : 0932	**STERILIZATION DATE :** 29-FEB-2024	**EXPIRE DATE :** 29-FEB-2029

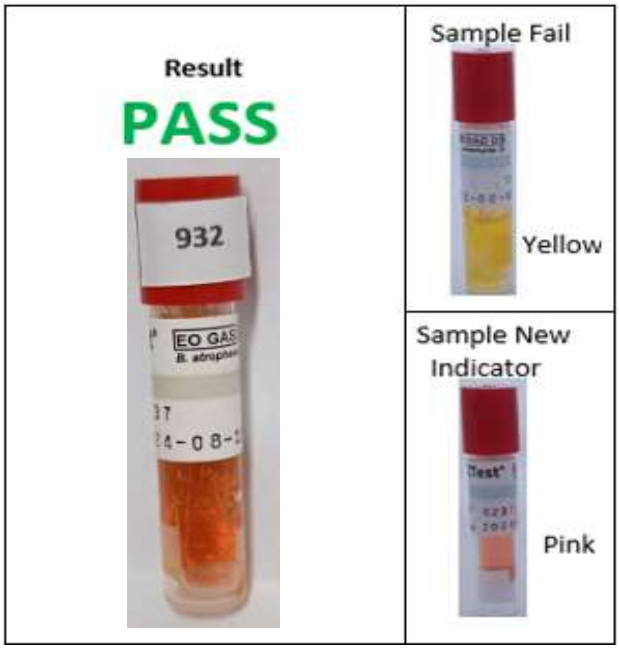
PASS as the test result has been shown as pictures below.

After the incubation period of 48 hours, the appearance of a yellow color indicates bacterial growth. No color change indicates adequate sterilization.
