EO STERILIZATION
Quality Control Report

Date : 26-Jul-2024

LOT : 0971	**STERILIZATION DATE : 17-Jul-2024**	**EXPIRE DATE : 17-Jul-2029**

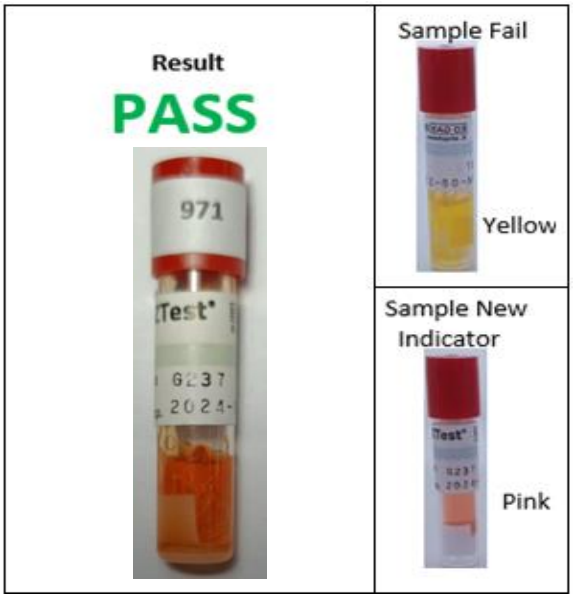
PASS as the test result has been shown as pictures below.
