EO STERILIZATION
Quality Control Report

LOT : 1021	**STERILIZATION DATE : 16-Nov-2024**	**EXPIRE DATE : 16-Nov-2029**

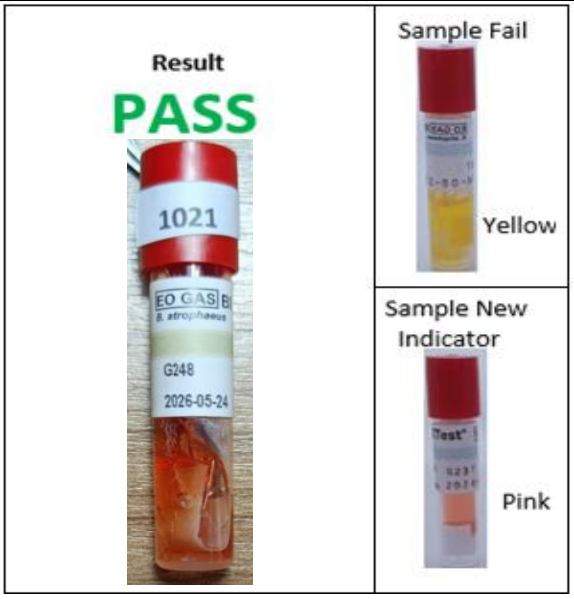
PASS as the test result has been shown as pictures below.

After the incubation period of 48 hours, the appearance of a yellow color indicates bacterial growth. No color change indicates adequate sterilization.
