EO STERILIZATION
Quality Control Report

LOT : 1046	**STERILIZATION DATE : 16-Feb-2025**	**EXPIRE DATE : 16-Feb-2029**

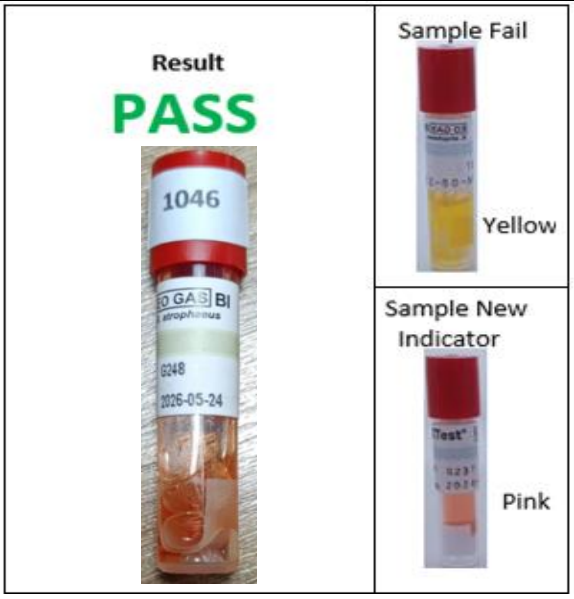
PASS as the test result has been shown as pictures below.

After sterilization the chemical indicator ring on the label changes from blue to brownish when exposed to Ethylene Oxide (EO gas). This distinguishes exposed from unexposed units (it does not indicate acceptable sterilization).

After the incubation period of 48 hours, the appearance of a yellow color indicates bacterial growth. No color change indicates adequate sterilization.
