EO STERILIZATION
Quality Control Report

LOT : 1056	**STERILIZATION DATE : 11-Mar-2025**	**EXPIRE DATE : 11-Mar-2029**

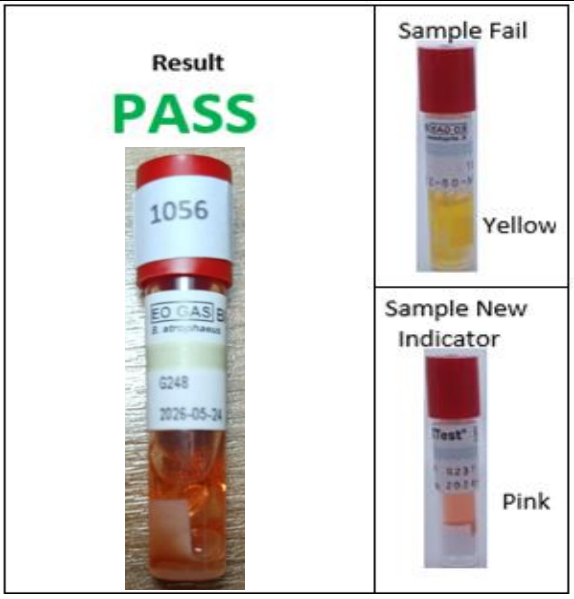
PASS as the test result has been shown as pictures below.

After the incubation period of 48 hours, the appearance of a yellow color indicates bacterial growth. No color change indicates adequate sterilization.
