EO STERILIZATION
Quality Control Report

LOT : 1098	**STERILIZATION DATE : 31-May-2025**	**EXPIRE DATE : 31-May-2029**

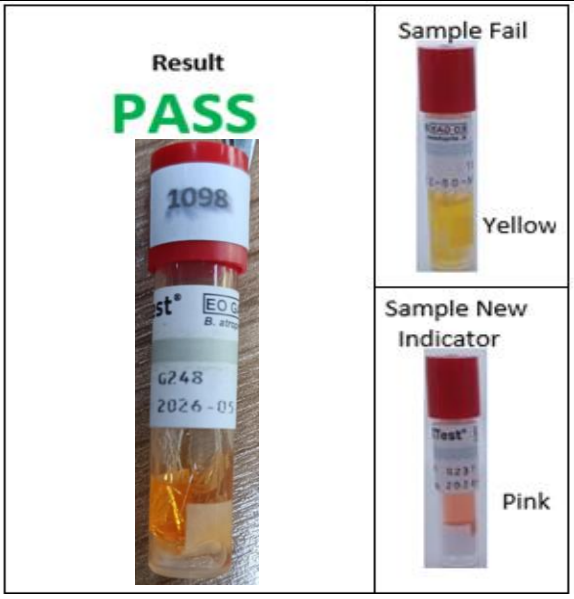
PASS as the test result has been shown as pictures below.

After sterilization the chemical indicator ring on the label changes from blue to brownish when exposed to Ethylene Oxide (EO gas). This distinguishes exposed from unexposed units (it does not indicate acceptable sterilization).

After the incubation period of 48 hours, the appearance of a yellow color indicates bacterial growth. No color change indicates adequate sterilization.
