EO STERILIZATION
Quality Control Report

LOT : 1158	**STERILIZATION DATE : 13-Sep-2025**	**EXPIRE DATE : 13-Sep-2029**

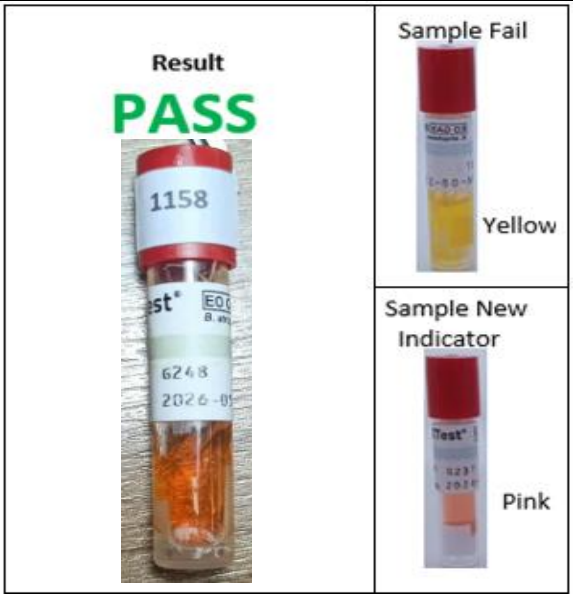
PASS as the test result has been shown as pictures below.

After the incubation period of 48 hours, the appearance of a yellow color indicates bacterial growth. No color change indicates adequate sterilization.
