EO STERILIZATION
Quality Control Report

Date : 03-Oct-2025

LOT : 1161	**STERILIZATION DATE : 27-Sep-2025**	**EXPIRE DATE : 27-Sep-2029**

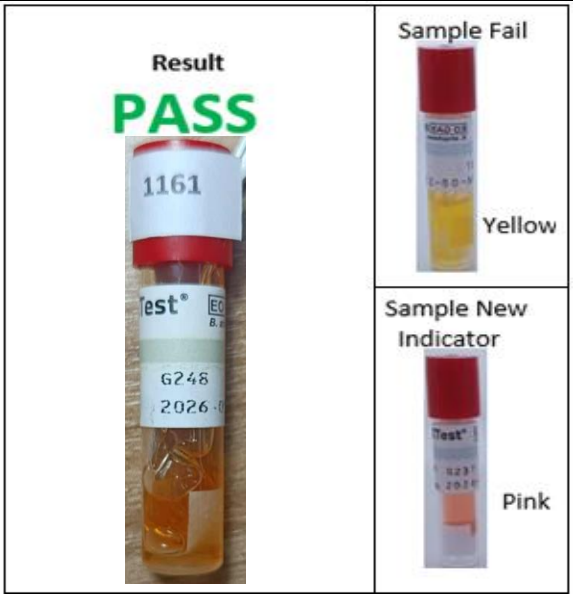
PASS as the test result has been shown as pictures below.

After the incubation period of 48 hours, the appearance of a yellow color indicates bacterial growth. No color change indicates adequate sterilization.
