EO STERILIZATION
Quality Control Report

LOT : 1289	**STERILIZATION DATE : 03-Sep-2026**	**EXPIRE DATE : 03-Sep-2031**

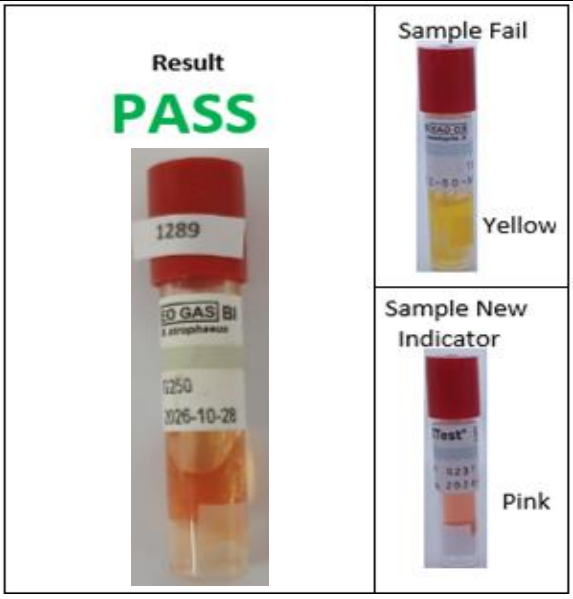
PASS as the test result has been shown as pictures below.

After the incubation period of 48 hours, the appearance of a yellow color indicates bacterial growth. No color change indicates adequate sterilization.
