EO STERILIZATION
Quality Control Report

LOT : 1293	**STERILIZATION DATE : 26-Sep-2026**	**EXPIRE DATE : 26-Sep-2031**

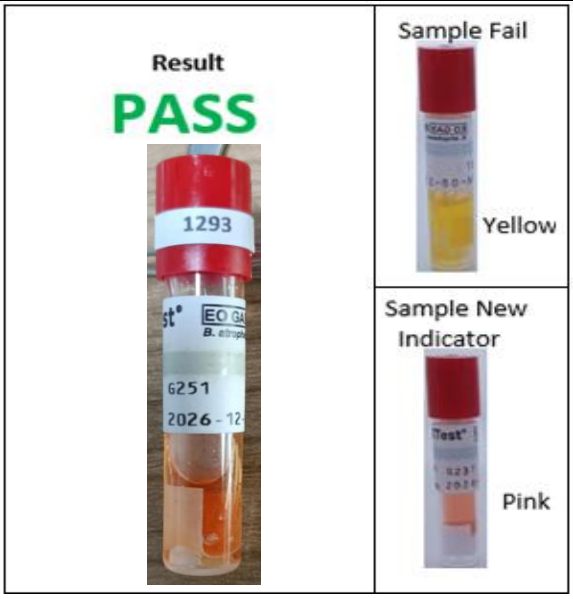
PASS as the test result has been shown as pictures below.

After the incubation period of 48 hours, the appearance of a yellow color indicates bacterial growth. No color change indicates adequate sterilization.
